Investigation of Potentially Expansive Soils, 'The Birches' Subdivision, Rangiora, New Zealand

A thesis
submitted in partial fulfilment
of the requirements for the degree
of
Bachelor of Science with Honours in Engineering Geology
at the
University of Canterbury
By
NICHOLAS CLENDON

University of Canterbury,
July 2001

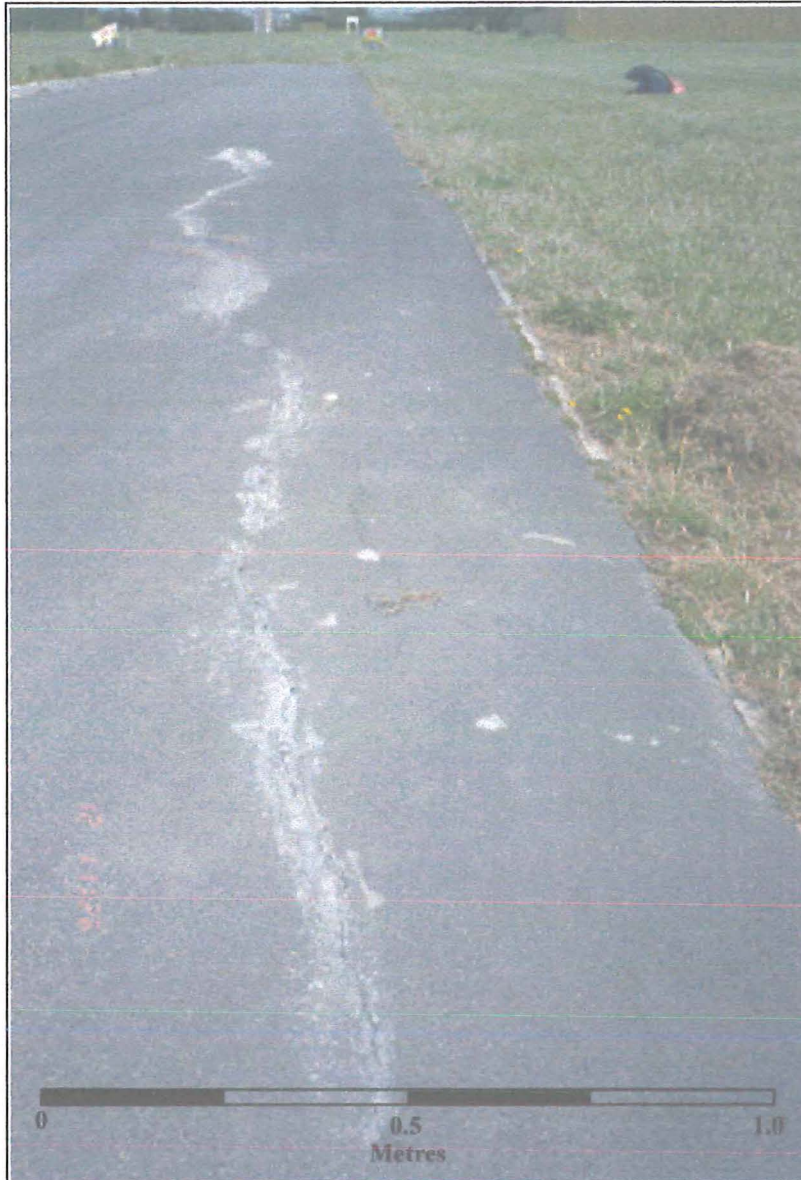
Figure 1.4 Photo of Access Drive to Lots 67 and 66

The access driveway constructed during Stage Two, which developed longitudinal cracks, runs off Hawkins Place (Figure 1.3) and provides access to Lots 66 and 67. The driveway was sealed in mid-to-late 1998, and consisted of 400mm of granular fill placed on top of the subgrade. Cracking occurred during the summer of 1998-1999. The cracks run down through the full thickness of the seal, and appear to be shrinkage cracks. It should be noted that a 100mm diameter sewer pipe (Figure 1.4) runs parallel to the cracks, although these are not the kind of cracks typically associated with poorly filled trenches. Cracks of this nature have not been found elsewhere in the subdivision. A photo of the driveway is shown in Figure 1.4.

Secondly, the initially high moisture content of the soil when the access drive to Lots 67 and 66 was sealed resulted in moisture gradients running parallel to the ground surface, as the asphalt acted as a impermeable membrane. This lead to either rotational failure (Figure 1.6) or crack propagation, resulting in cracking of the asphalt
